**North Coast Integrated Regional Water Management Plan
Proposition 84 Round 1 Implementation Grant**

Priority Project Photo Pages

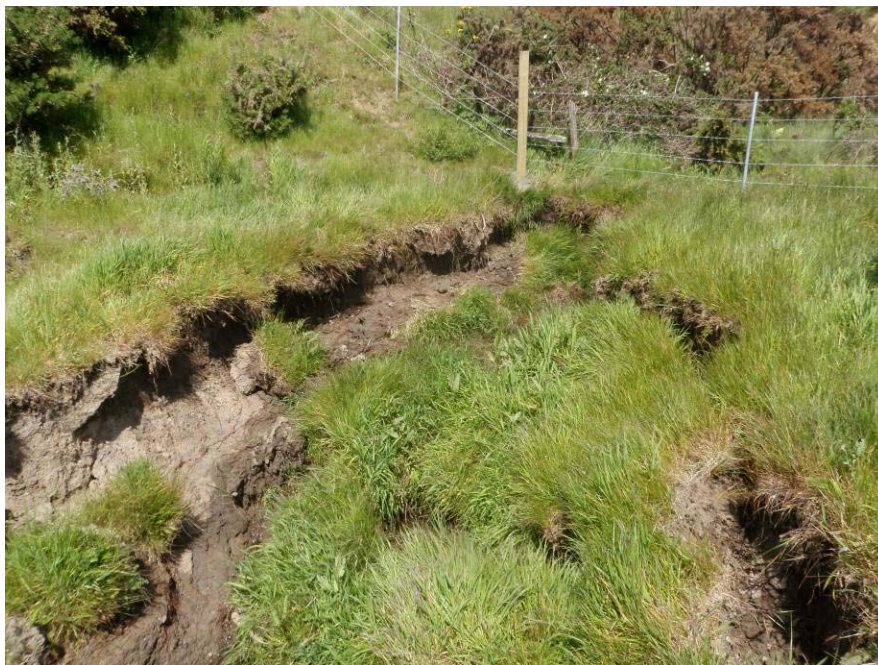
Photo description: Erosion in the Estero Americano Watershed

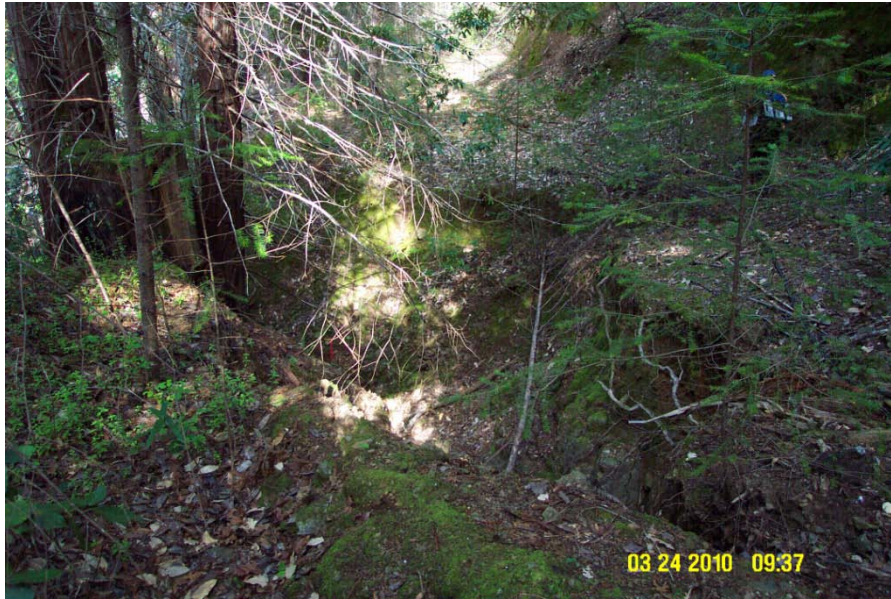
Photo description: This stream crossing has eroded through road fill. This gully will continue to expand and migrate back through the road fill. We plan to properly install a 24" x 60' culvert at this location to stop the erosion from occurring and allow the landowners to access a significant portion of their property once again.

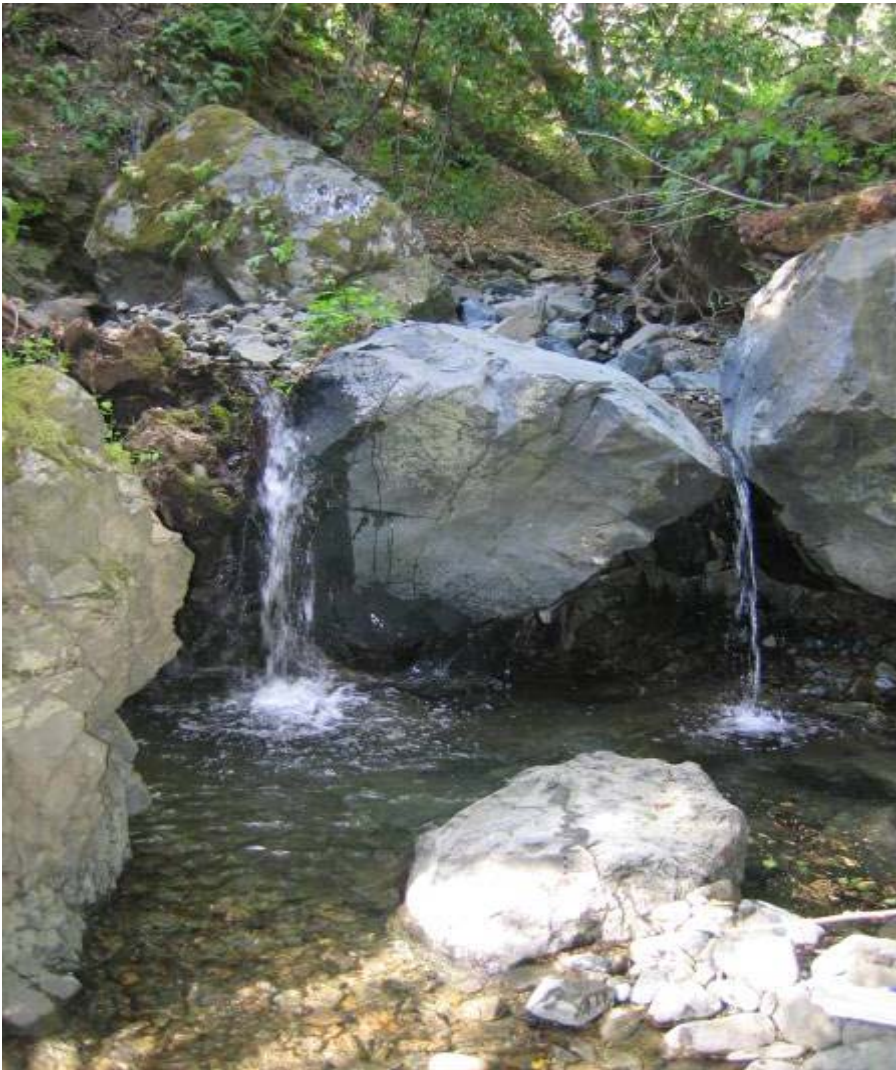
Photo Description: Plunge pool (Unit #304) on upper NissaKah Creek with a drop of approximately six to seven feet. No fish were observed upstream of this pool.

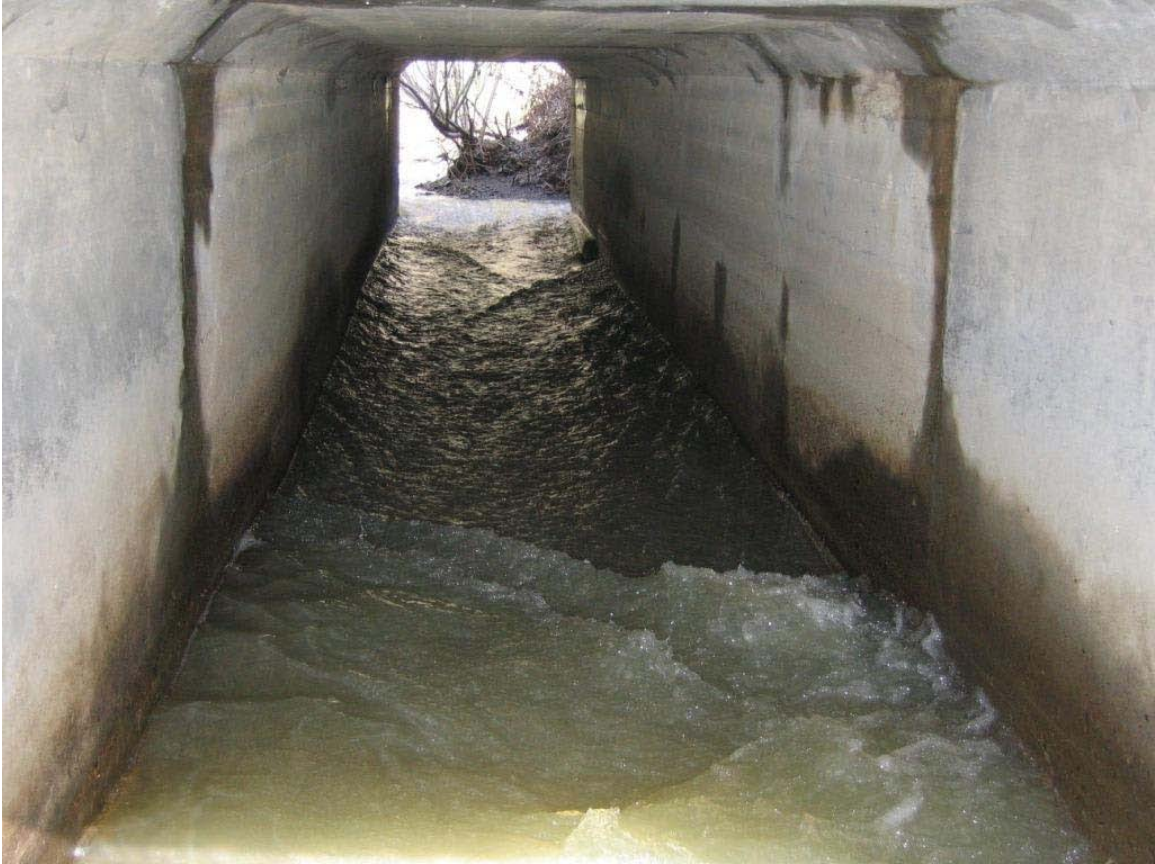
Photo Description: Highway 175 culvert on NissaKah Creek – looking upstream from outlet – note change in hydraulics at point where crossing had been lengthened from original construction.

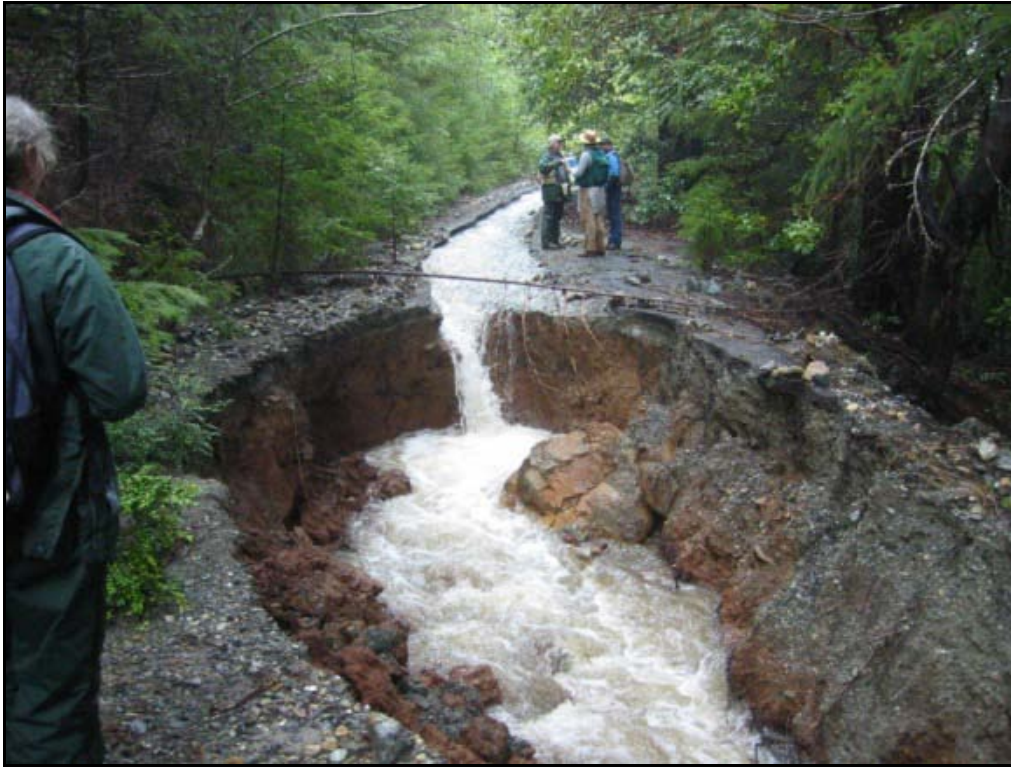
Photo Description: Resulting slide from stream diversion directly impacting bluff

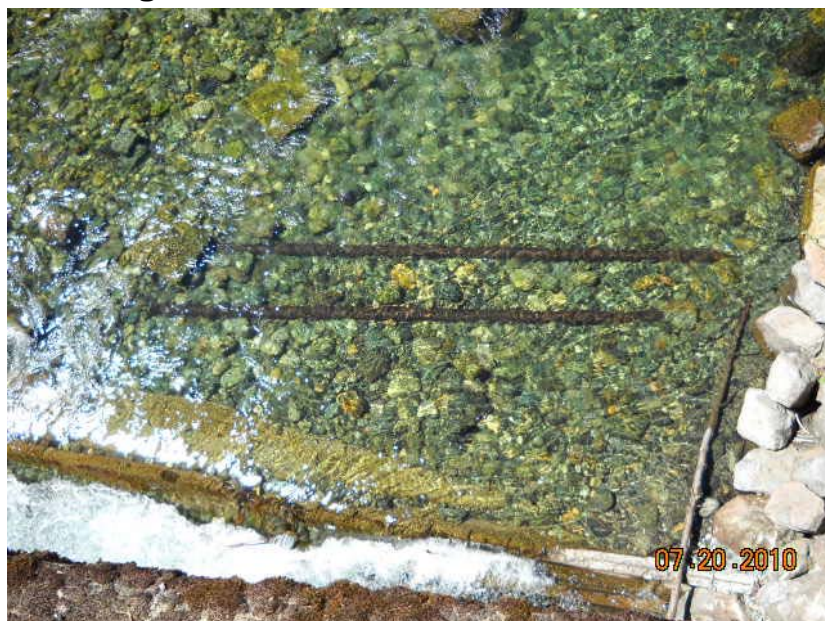
Photo Description: Exposed sewer pipeline crossing in Indian Creek just upstream of the Highway 96 Bridge. The two 6-inch diameter brown ductile iron pipes (left to right in the photo) are subject to damage from water, rocks, loose trees, and undermining during high flows. (View is from the Highway 96 Bridge looking upstream.)

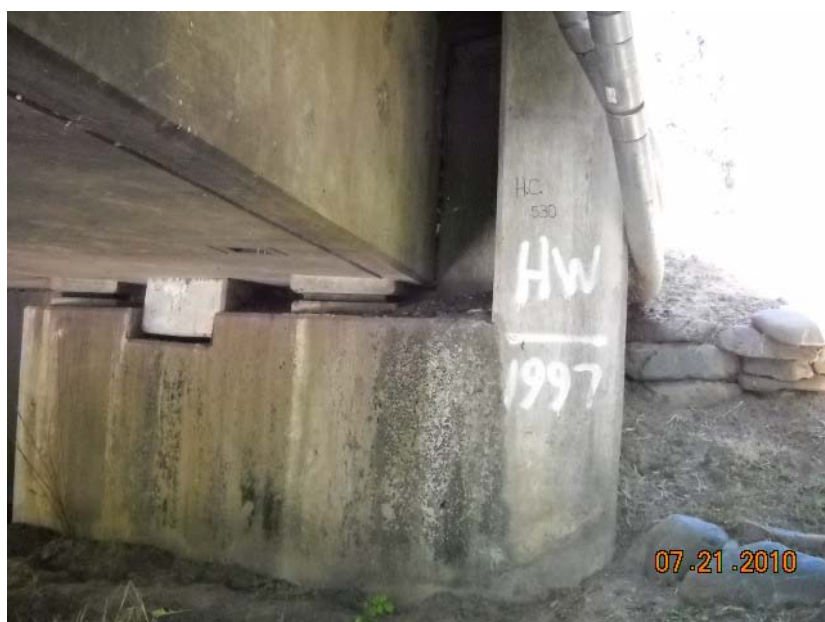
Photo Description: The high water mark on the downstream bridge abutment for the 1997 flood was just below the bottom of the bridge. The high water mark is about 20 +/- feet above the creek bed. (If you were in the creek and looking downstream, this bridge abutment would be on your left.)

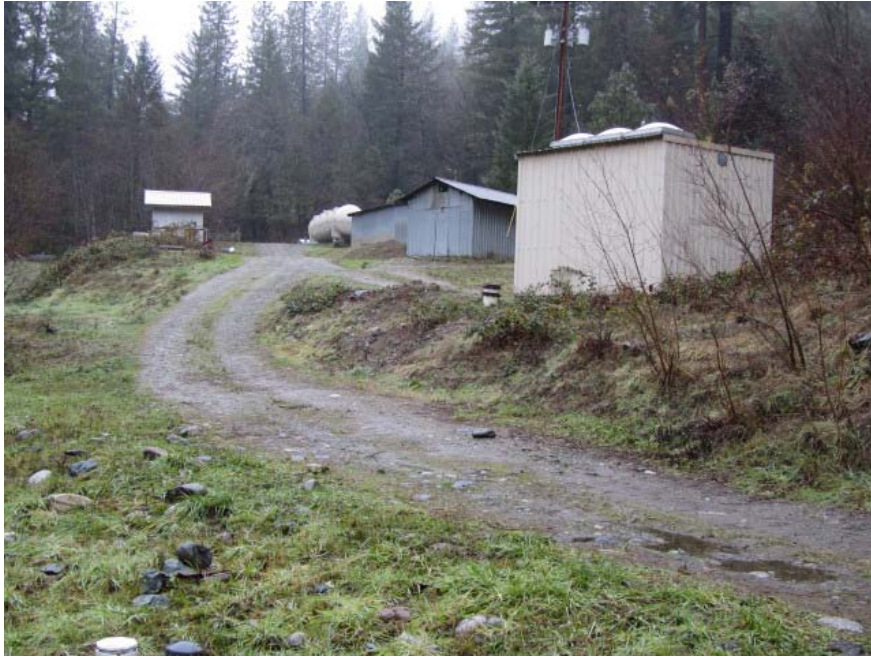
Photo Description: Existing Off-White Wetwell Building in foreground. Blue and white electrical and utility sheds and one of the pressure filters at higher elevations in the background (view looking uphill from the bank of Elk Creek) - Existing electrical equipment for wetwell Pumps in the wetwell building will be relocated adjacent to one of the other structures at a higher elevation and a safe distance from the 100-year floodplain.

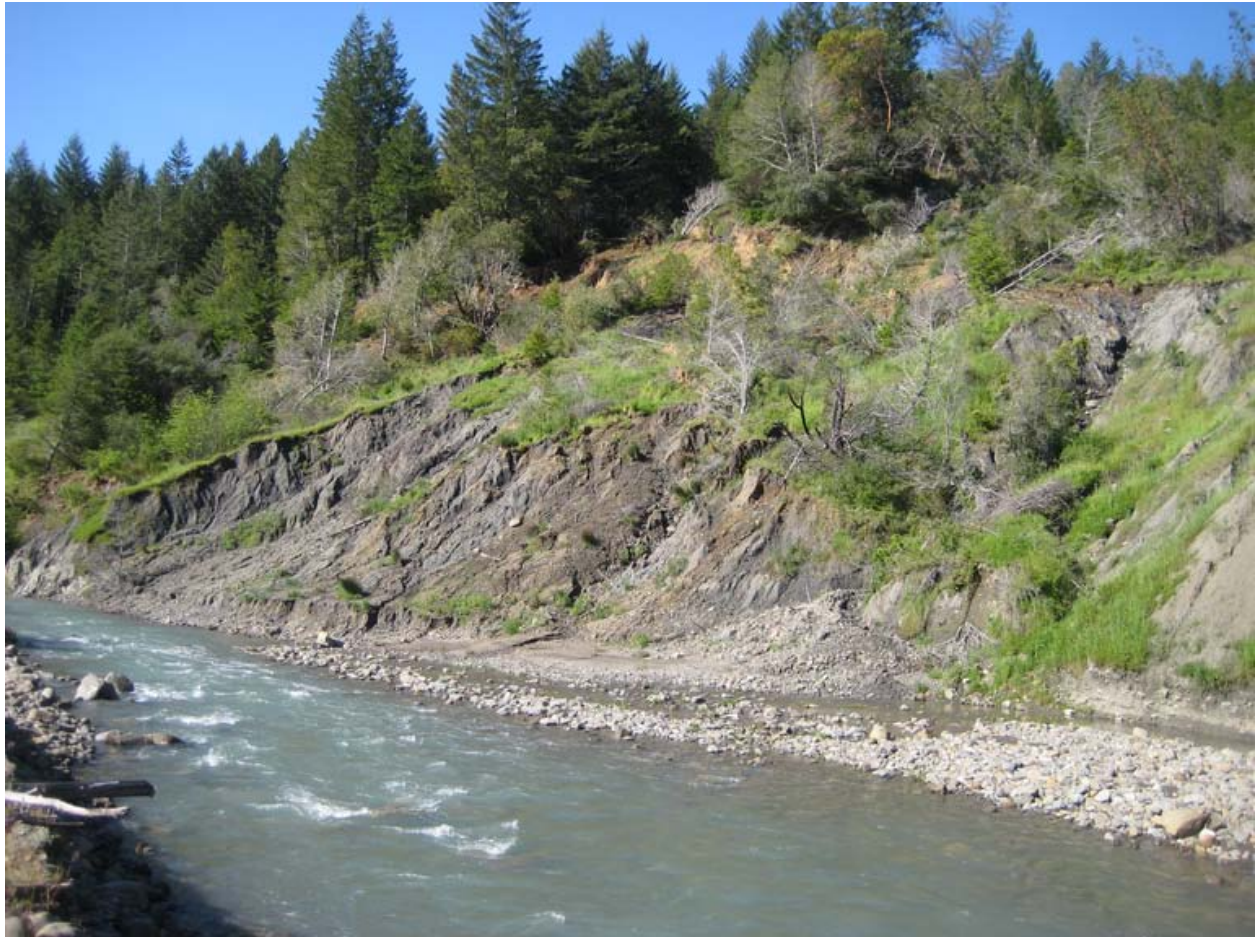
Photo Description: The debris slide depicted in this photo is actively delivering sediment into the Upper North Fork Mattole River. Following the installation of bioengineered riprap rock and large wood structures (not funded through this project), extensive planting of native riparian trees and shrubs will take place to provide added bank stabilization, increase riparian shade, and improve salmonid habitat.

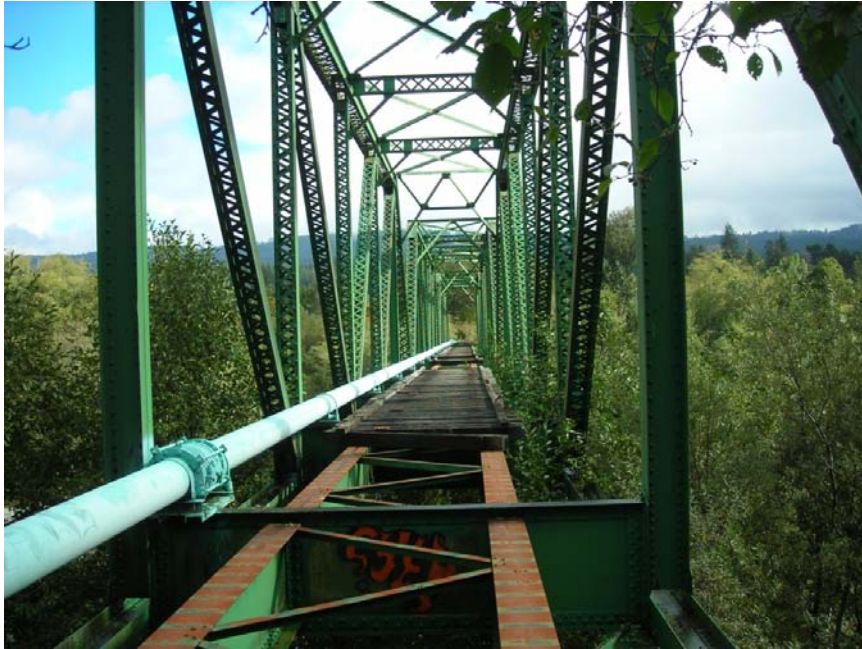
Photo description: Existing trestle with missing deck and ties showing pipeline.

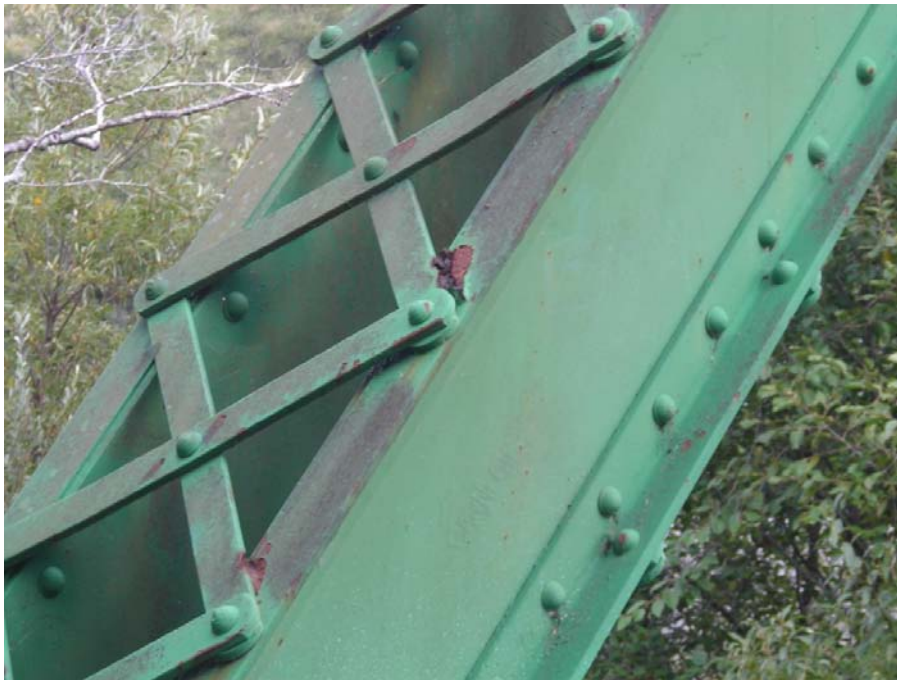
Photo description: Typical structural deterioration on portal bracing and inclined end posts.

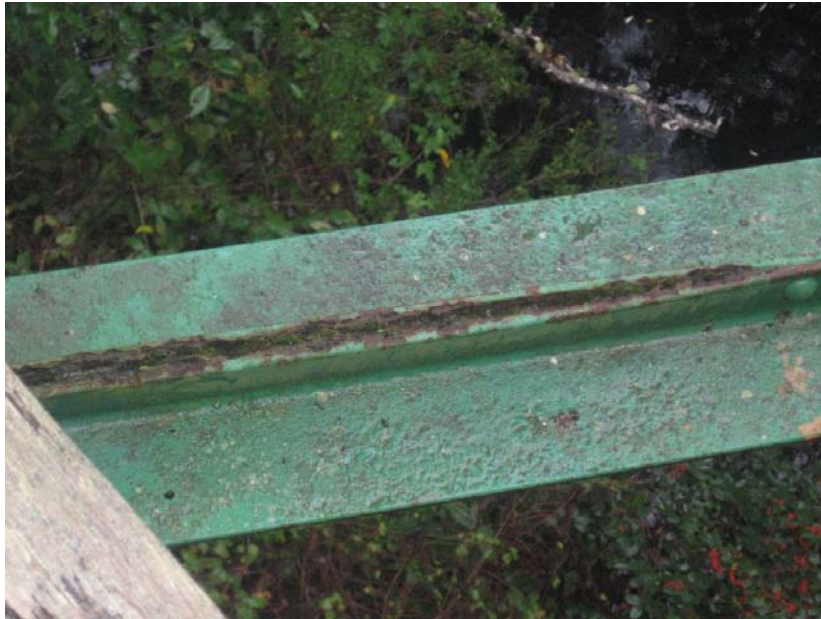
Photo description: Typical structural deterioration on stringers and floor beams.

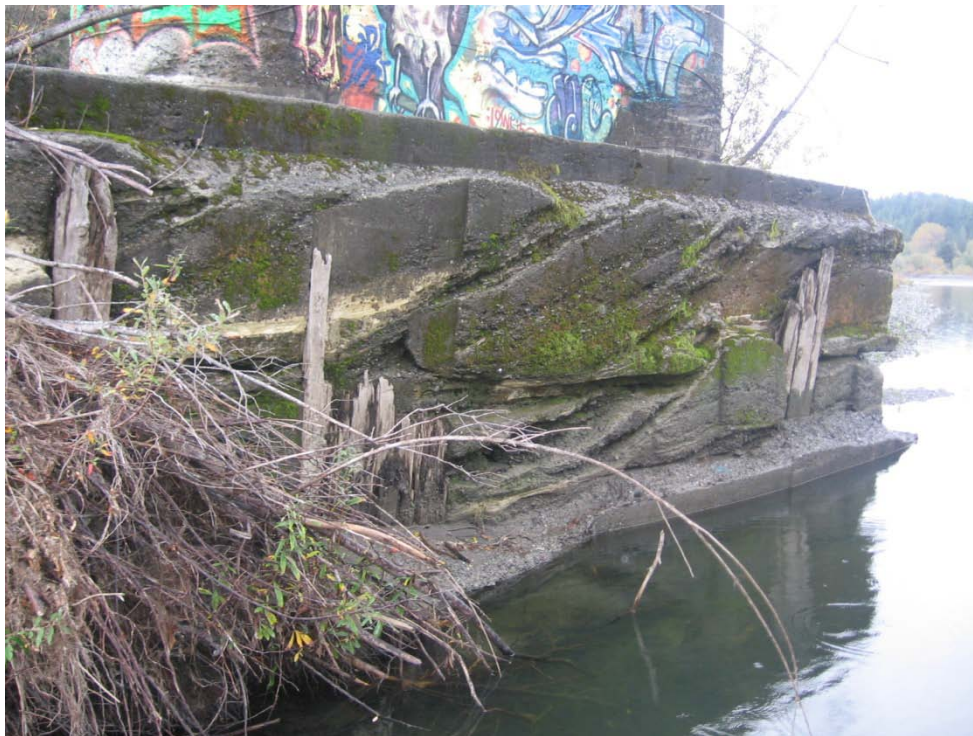
Photo description: Typical abutment/pier deterioration.

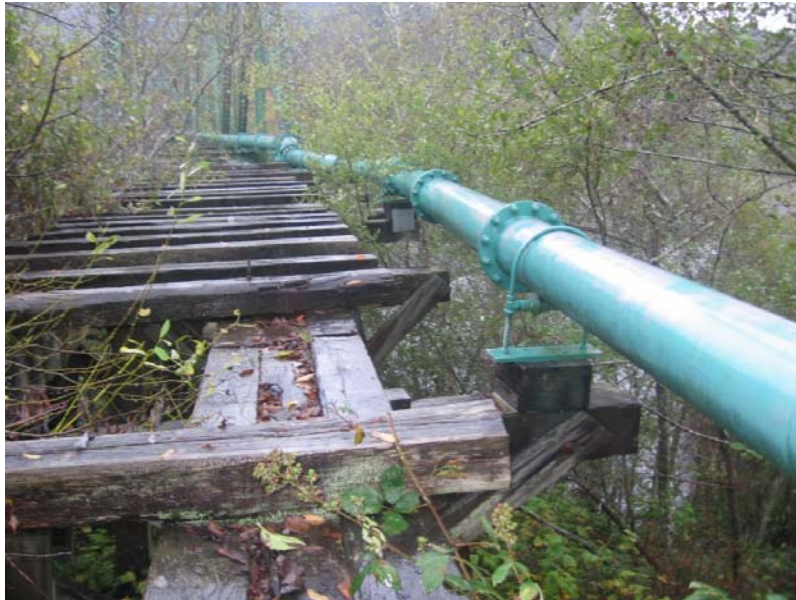
Photo description: Typical deck and tie deterioration including pipeline.

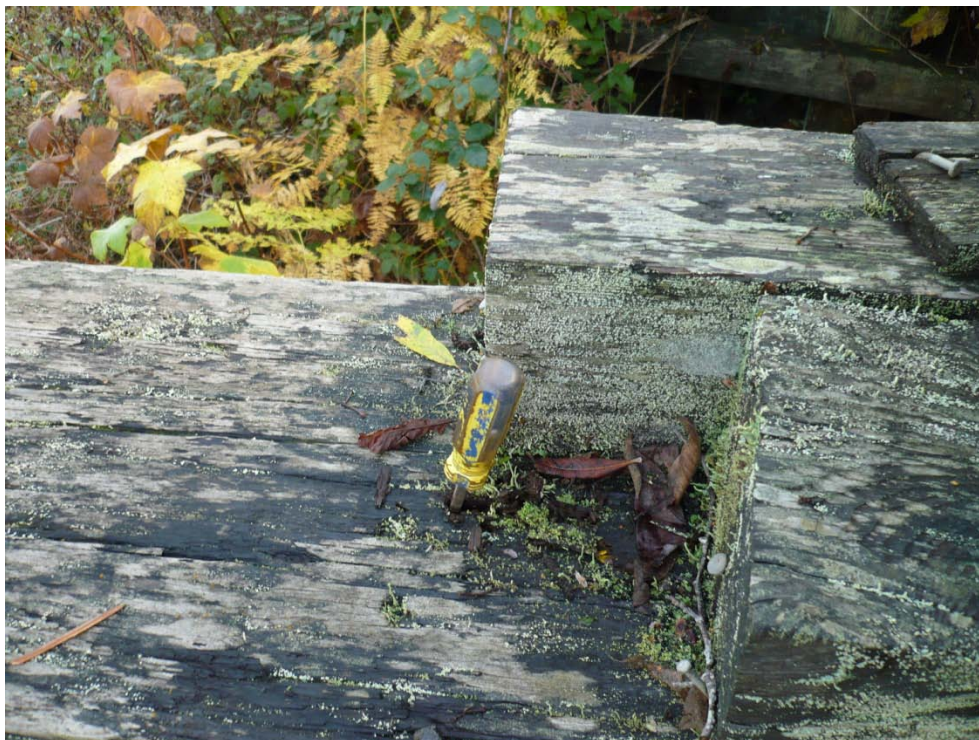
Photo description: Typical deck rot.

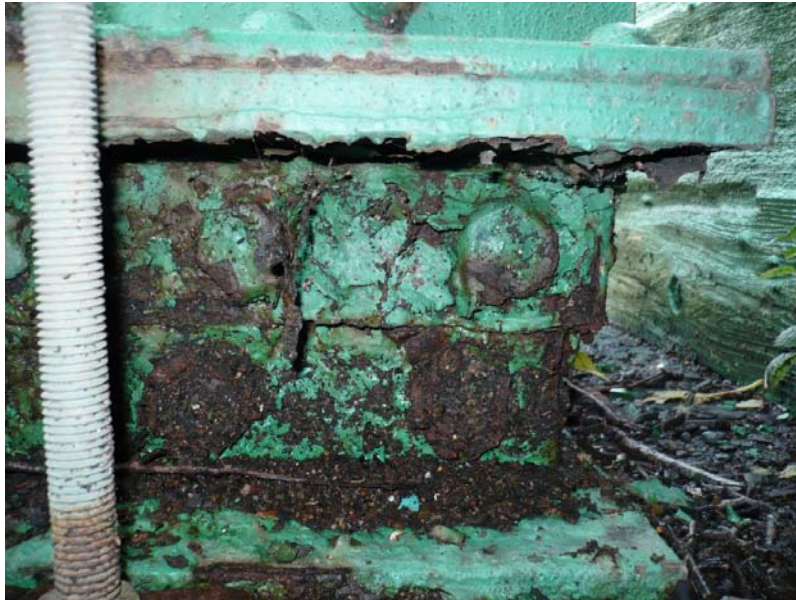
Photo description: Typical abutment connection deterioration.

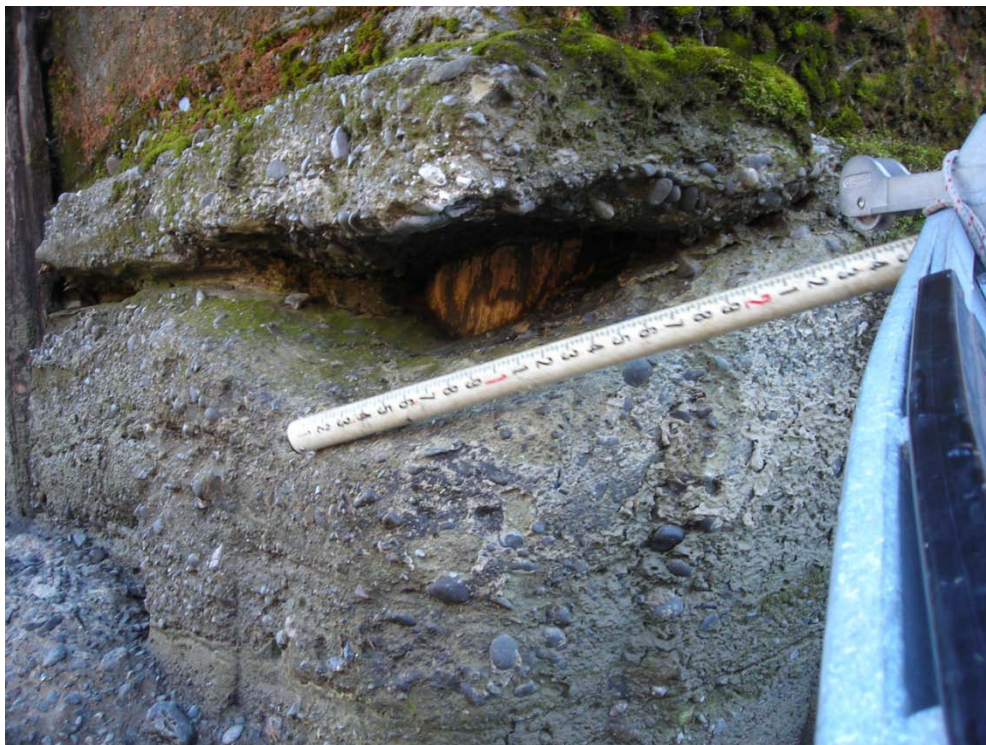
Photo description: Pier deterioration that has exposed timber pile support.
